Manhole Inspection Summary

Manhole # S39E__026MH

Insp Date: **11/7/08 10:46 AM**

Location Address: **924 n high st**

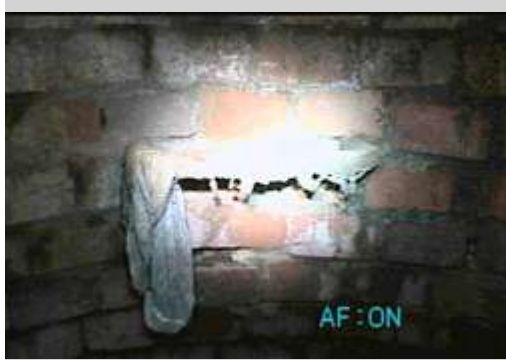
Defect 6

☒ **Evidence Of Surcharge**

Depth: **4.** (ft.) ☐ Active Surcharge Present
41

surcharge evd

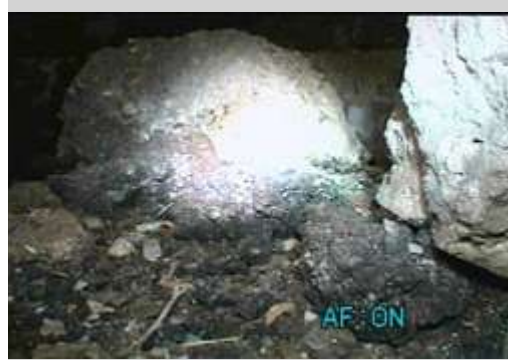
Defect 5

Condition: ☐ Sound ☐ Cracked ☐ Root Intrusion ☐ Deteriorated ☐ Leaks ☒ **Debris**

channel debris

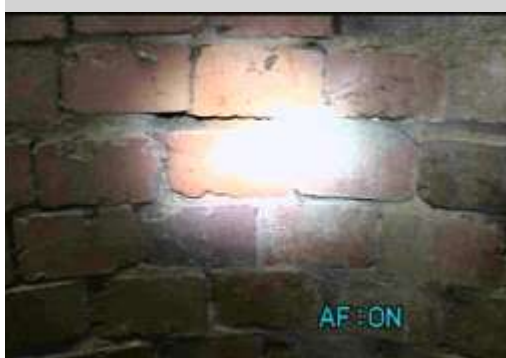
Defect 4

Condition: ☐ Sound ☐ Cracked ☐ Root Intrusion ☐ Loose Brick ☒ **Deteriorated**

corbel deteriorated

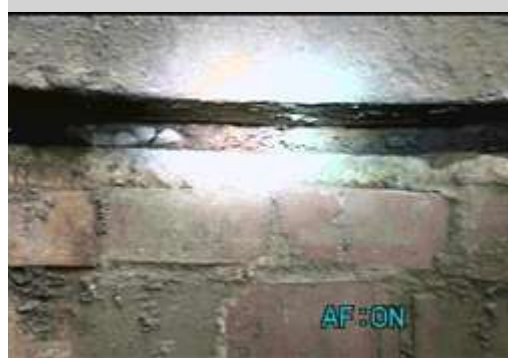
Defect 3

Condition: ☐ Sound ☐ Cracked ☐ Root Intrusion ☒ **Loose Brick** ☒ **Deteriorated**

loose bricks, deteriorated

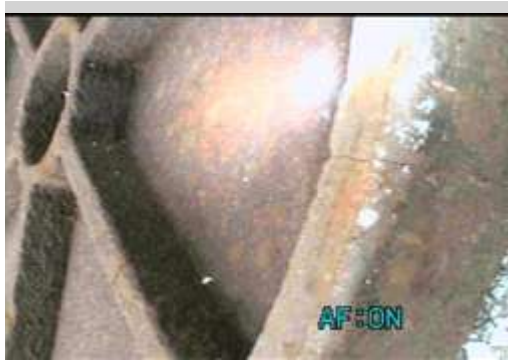
Defect 2

Condition: **Cracked**

cracked cover

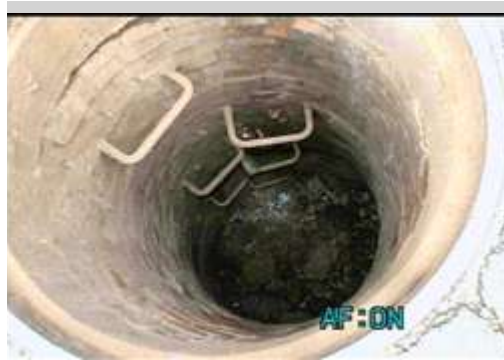
Defect 1

Count: **6** Missing: **0** ☒ **Corroded**

corr steps
